Manhole Inspection Summary

Manhole # S55A__020MH

Insp Date: **6/24/08 8:48 AM**

Location Address: **rear 3600 e fayette st**

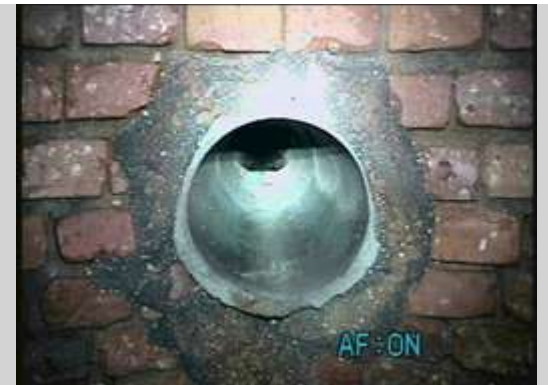
3 O'Clock Inflow

Pipe Height: **0** (in.) Direct
Pipe Material: **Clay** ☐ Pipe Lined
Invert Depth: **7.70** (ft.) Flow Characteristics: **Fast**
Deposits: ☒ None ☐ Mud ☐ Gravy ☐ Debris ☐ Grease
Silt Depth: **0** (in.) Deposits Extent:
Infiltration: **None** Pipe Seal Cond: **Unknown**

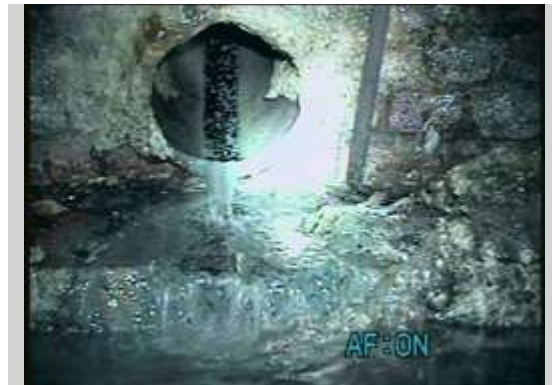
Drop In @ 3 OClock

Drop: **Outside Direct**
Angled: Reading: **0.00** (ft.)
Inv Depth: **10.90** (ft.)
Drop Condition: **Open**
